**OFFICE OF THE SPECIAL INSPECTOR GENERAL
FOR AFGHANISTAN RECONSTRUCTION**

**INSPECTION OF HABIB RAHMAN SECONDARY SCHOOL
CONSTRUCTION PROJECT IN KAPISA PROVINCE:
DESIGN AND SAFETY ISSUES REQUIRE ATTENTION**

SUBJECT: SIGAR Inspection Report 10-3: Inspection of Habib Rahman Secondary School
Construction Project in Kapisa Province: Design and Safety Issues Require Attention

Inspection of Habib Rahman Secondary School Construction Project in Kapisa Province: Design and Safety Issues Require Attention

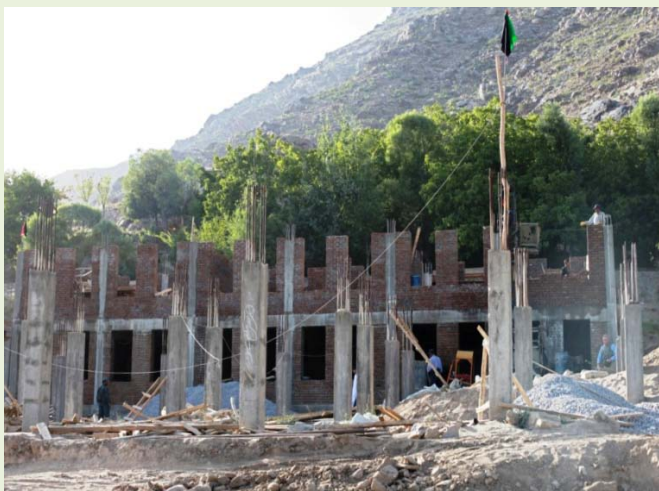
- Unfinished work left over from earlier construction at the site continues to cause major design and safety issues. The contract does not require the removal of this unfinished structure and currently there are no plans to have it demolished. SIGAR believes this abandoned construction site occupies valuable space which could be used for a number of other purposes. Additionally, it presents an unsafe environment for school children.

View of new school construction obscured by the unfinished and unusable structure of a previous construction project. (Photo provided by SIGAR)

That the Commander, U.S. Forces-Afghanistan and Commander, Kapisa PRT initiate a follow-on CERP project to correct the design and safety deficiencies noted in this report.

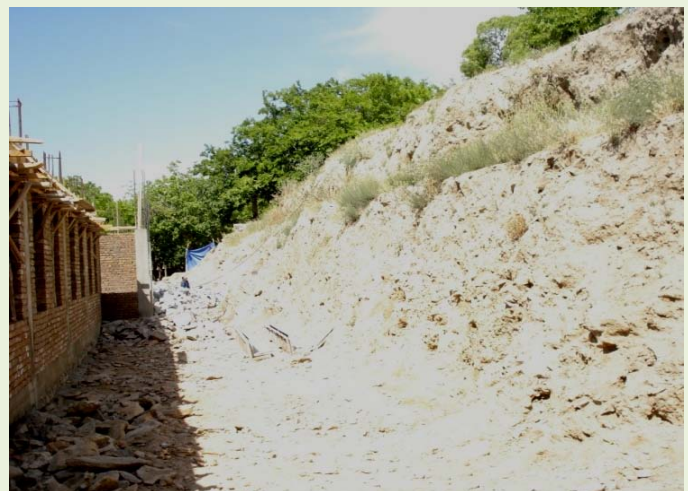
- The lack of a reinforced retaining wall and the associated earth removal work needed in the rear of the school which is adjacent to the base of a hill could pose a hazard to building occupants from potential rock and mud slides. This problem resulted from the decision to build the new school behind the unfinished work site which required the contractor to excavate a portion of the hill to make room for the new construction. The existing masonry security perimeter wall is insufficient to protect the school from debris falling from the hillside.

View of the limited offset distance from the base of a hill which could be subject to rock and mud slides. (Photo provided by SIGAR)

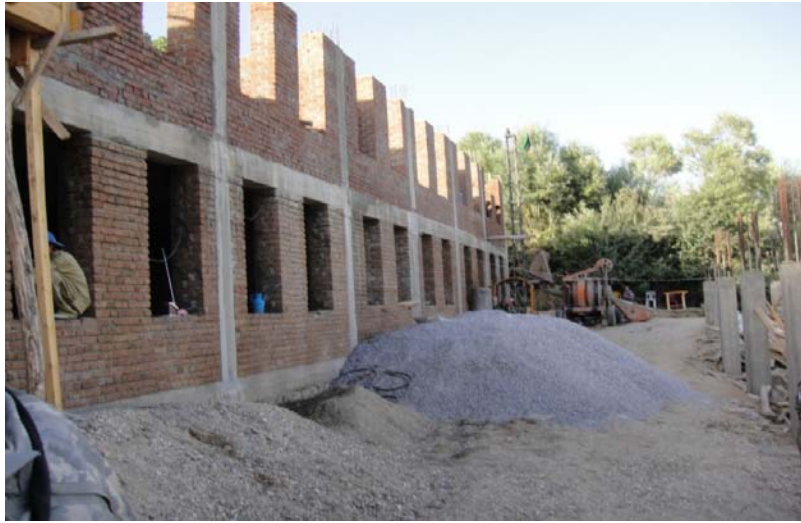
Site Photo 1: View of partially completed school building. Portions of the previously constructed and abandoned structure can be seen to the right of the photograph. (Photo provided by SIGAR)

At the time of SIGAR's inspection in August, it was estimated that the project was almost 50 percent complete (see Site Photo 1) with significant progress made on the main school building and perimeter wall.

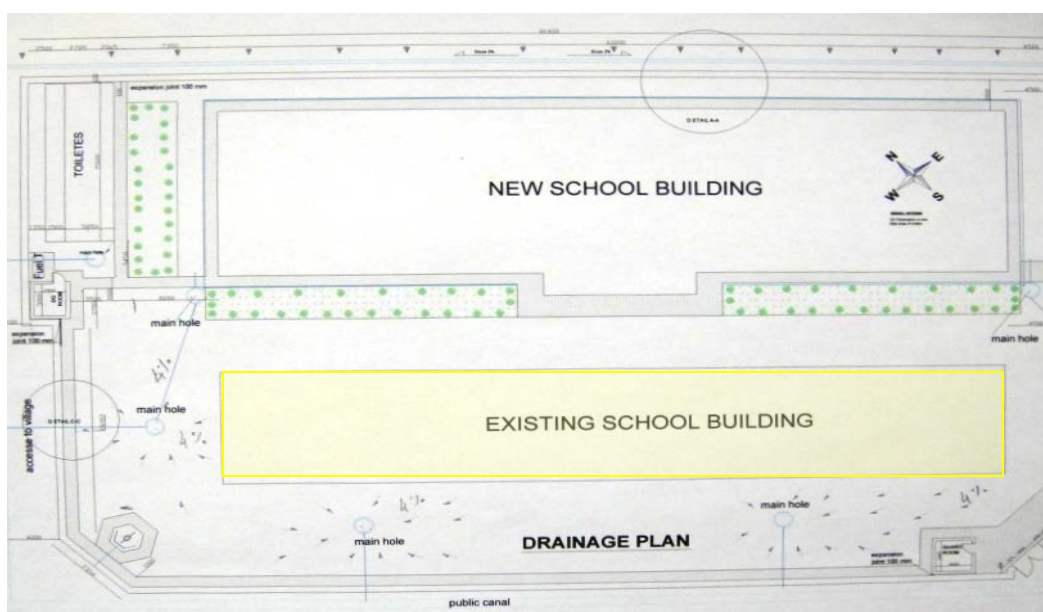
Figure 2: Design Plan for the Habib Rahman Secondary School which builds around a previously built, unfinished structure (shaded in yellow) rather than demolishing it. (Illustration provided by Kapisa PRT)

The first design flaw in the project noted by SIGAR focuses on the existence of a previously constructed but unfinished and unsafe structure (see Site Photo 2 and Figure 2) which occupies valuable land that could be used for a number of other purposes.³ When the Kapisa PRT became involved in the school project in the summer of 2008 following discussions with the Provincial Director of Education, it was decided that the existing structure should not be used because of concerns regarding its structural soundness. The current contract did not require the removal of this prior construction and PRT officials noted that they do not have plans to remedy this problem. SIGAR could not determine why this unfinished and unsafe structure was not demolished as part of the initial project proposal except for statements from the current PRT staff which indicated that local authorities believed they could make use of the unfinished structure. Despite attempts to

RECOMMENDATION 1: SIGAR recommends that the Commander, U.S. Forces-Afghanistan and Commander, Kapisa PRT initiate a follow-on CERP project to correct the design deficiencies noted in this report to include demolishing the previously built but unusable structure on the school compound, and constructing a protective retaining wall at the rear of the new school in place of the perimeter wall. (page 6 of SIGAR report)

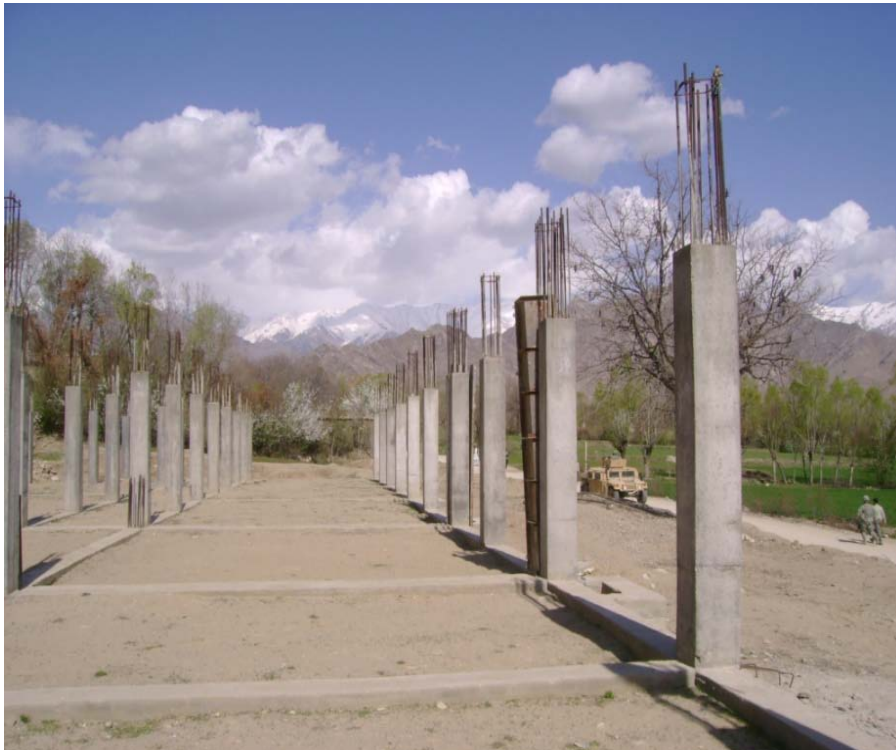
³ Several years ago, prior to the initiation of this CERP project, an international non-governmental organization started construction of a school building on the same site. The partially built structure was never completed due to a number of contractual and structural problems encountered during construction.

Site Photo 2: View of earlier school construction that was left unfinished and abandoned for several years. This abandoned structure stands directly next to the main road leaving no clearance room for further construction in front. (Photo provided by Kapisa PRT)

Demolition of old buildings is an approved project category. If the cleanup meets one of the Commander's objectives then this could be a legitimate CERP project, although this seems like a job the community might be able to accomplish themselves.

KP PRT RESPONSE: Kapisa PRT partially concurs with information provided in this SIGAR Report. A follow-on project should be implemented for correcting the rear security wall and potentially adding a retaining wall and proper drainage. The reinforced concrete frame of the previously built school was left on site at the request of Nijrab government officials and local shura leaders. The engineers of the area are working to get funding to build a small community center and/or library on the site that may use some of the existing structure.

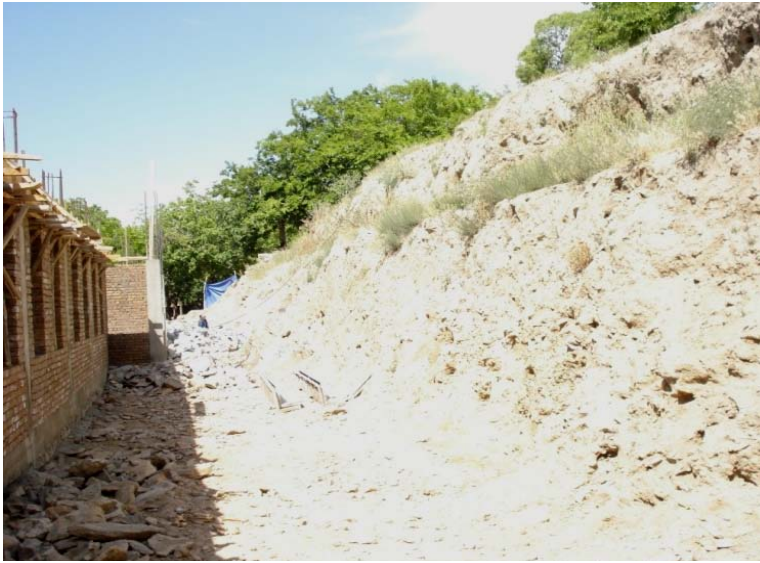
In order to make room for the present construction site, which had to be built around the abandoned construction site, the contractor was required to excavate an extensive area 50 meters into the adjacent hillside. For this reason, the new school building was constructed adjacent to an embankment at the base of a steep hillside (see Site Photo 3) near a flood plain that was graded in order to accommodate the new school compound.

SIGAR found that the rear of the school building abuts the base of the embankment slope of the hill leaving a space of less than 2 meters between the perimeter wall and the rear wall of the school. Proper construction of a retaining wall requires masonry reinforcement of the wall as well as a footing constructed to the correct dimensions. Such a retaining wall is needed to hold back potential rock and mudslides. SIGAR considers the absence of a retaining wall to be a significant deficiency because the embankment slope may be subject to rock and mud slides that could pose an imminent hazard to building occupants.

SIGAR believes that the Kapisa PRT Quality Assurance Representative responsible for the planning of this project should have insisted on the construction of an appropriately designed retaining wall, as well as additional site grading to ensure an adequate offset between the school and the embankment was included in the original statement of work. These steps would have produced an adequate and safe school structure that would protect its occupants from landslides and other site hazards.

Site Photo 3: View of the embankment at the rear of the school building. Although a perimeter wall was subsequently built, it does not afford the structural protection against mud and rockslides that a properly designed and constructed retaining wall would provide. (Photo provided by Kapisa PRT)

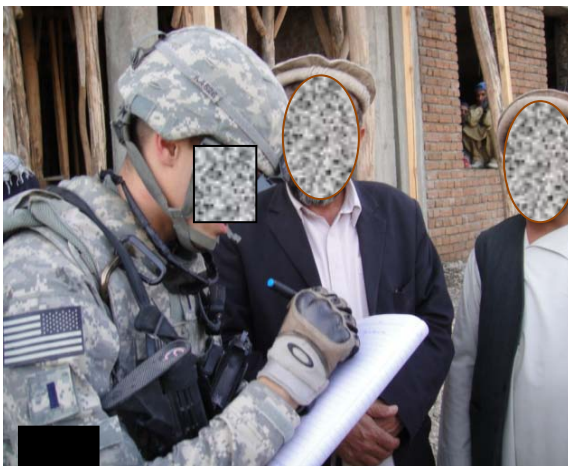
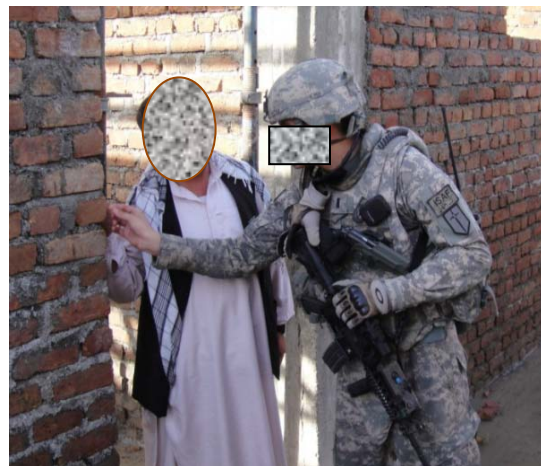
At the time of SIGAR’s June site visit, key project management documents such as a proper Quality Control Plan, work schedules, and routine progress reports from the contractor, were largely missing from the project file. SIGAR believes the Kapisa PRT’s management of the project, as well as the conduct of its Quality Assurance Program, were inadequate during the initial stages of this project as evidenced by the numerous contracting missteps discussed earlier. However, SIGAR found that both the contractor’s and the PRT’s quality review systems improved significantly between our June and August site visits as a result of increased interest in the project on the part of the PRT. Improvements implemented during this time period included regularly scheduled visits by the PRT’s Quality Assurance Representative (see Site Photos 4 and 5 below), the filing of daily progress reports by the contractor, and development of a “coaching” program to teach proper construction techniques to work crews by the PRT. These improvements have largely corrected the earlier performance problems observed by SIGAR for the new school construction.

Site Photos 4 and 5: View of Kapisa PRT’s Quality Assurance Representative inspecting construction progress. (Photo provided by SIGAR)
